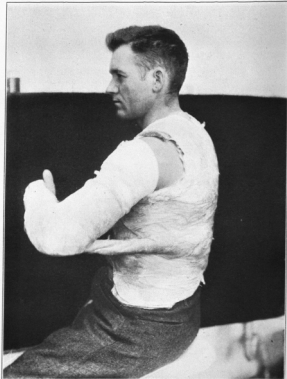
FIG. 12.—Compound, comminuted fracture involving shoulder joint. Cast in position of abduction; hand wing-inflated. Note windows cut for dressing and pelvic support
